## 5.0 LAND

### 5.2 TOPOGRAPHY/GEOMORPHOLOGY

## **5.3 GEOLOGY AND SOILS**

# Powerlink Western Downs EIA Topography

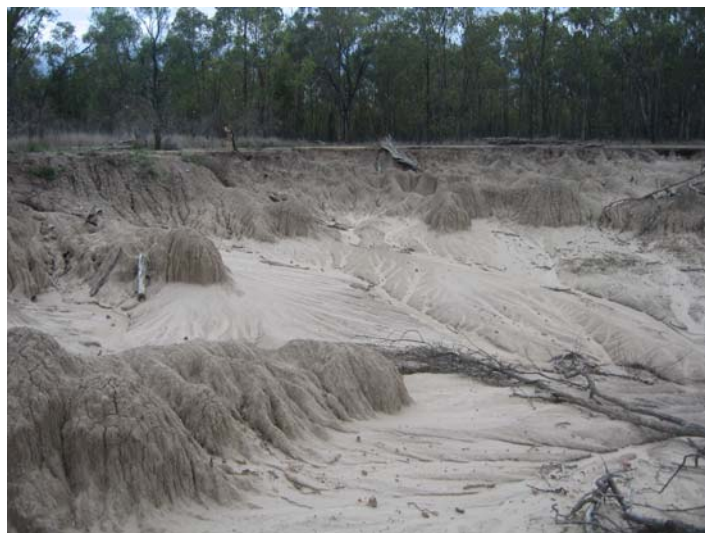
The study of the proposed alignment revealed two potential erosion hotspots. The main area of concern is located within the existing Kogan to Braemar alignment, adjacent to Kogan Creek (refer to Plate 5.1). The underlying precursor to the present erosion is likely to be the disturbance of the surface soil and the exposure of sodic subsoils and the steepness of the watercourse bank (Kogan Creek) adjacent to the erosion. It should be noted that anecdotal evidence suggests that this erosion was in place prior to the construction of the Kogan to Braemar alignment. Previous advice by the Department of Natural Resources and Water (at the time of construction of the Kogan to Braemar line) to Powerlink regarding this erosion was to leave the erosion in its current state and ensure that any activities in the area did not exacerbate the situation by altering or concentrating water flows.

**PLATE 5.1                      SIGNIFICANT EROSION ADJACENT TO KOGAN CREEK.**

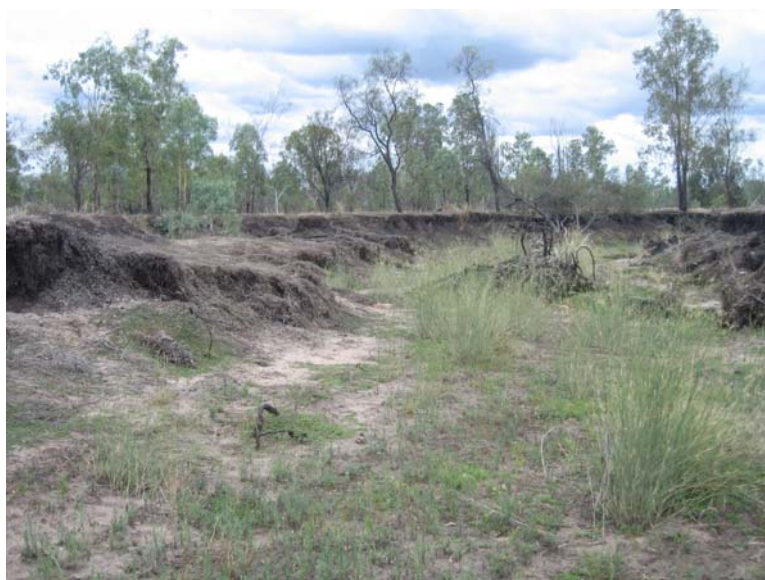
The other erosion hotspot is adjacent to Braemar Creek (refer to Plate 5.2). The erosion is likely to be associated with the by wash of a large dam installed on the creek.

## PLATE 5.2      EROSION WHICH IS LIKELY TO BE ASSOCIATED WITH THE BRAEMAR CREEK DAM.
