## 5.0 LAND

# Powerlink Western Downs EIA Topography

# Powerlink Western Downs EIA

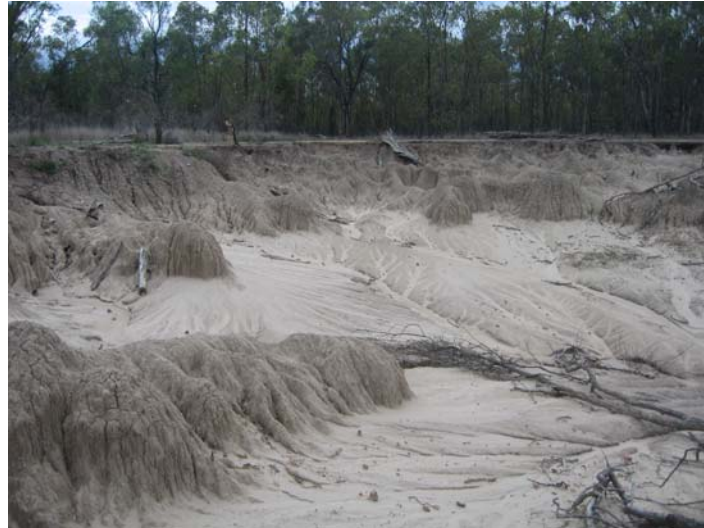
The study of the proposed alignment revealed two potential erosion hotspots. The main area of concern is located within the existing Kogan to Braemar alignment, adjacent to Kogan Creek (refer to Plate 5.1). The underlying precursor to the present erosion is likely to be the disturbance of the surface soil and the exposure of sodic subsoils and the steepness of the watercourse bank (Kogan Creek) adjacent to the erosion. It should be noted that anecdotal evidence suggests that this erosion was in place prior to the construction of the Kogan to Braemar alignment. Previous advice by the Department of Natural Resources and Water (at the time of construction of the Kogan to Braemar line) to Powerlink regarding this erosion was to leave the erosion in its current state and ensure that any activities in the area did not exacerbate the situation by altering or concentrating water flows.

**PLATE 5.1**                      **SIGNIFICANT EROSION ADJACENT TO KOGAN CREEK.**

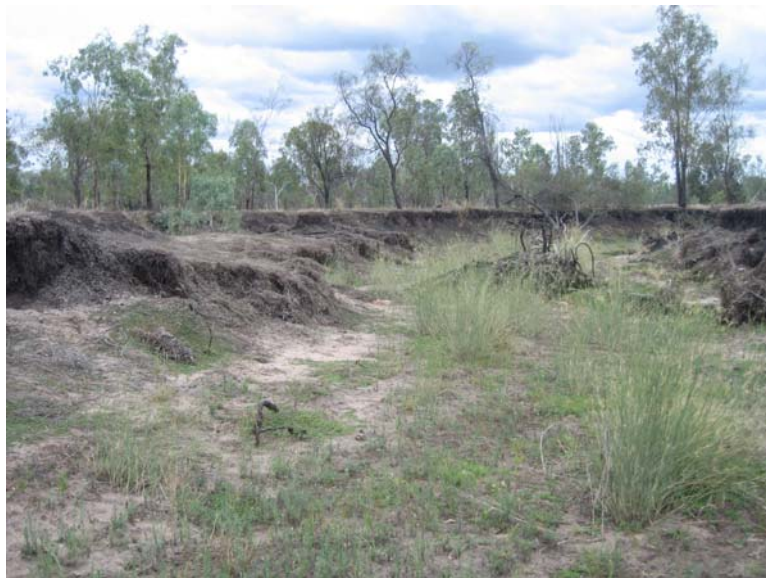
**PLATE 5.2**

The other erosion hotspot is adjacent to Braemar Creek (refer to Plate 5.2). The erosion is likely to be associated with the by wash of a large dam installed on the creek.

**EROSION WHICH IS LIKELY TO BE ASSOCIATED WITH THE BRAEMAR CREEK DAM.**
